# Manhole Inspection Summary

Manhole # S13QQ1022MH

Insp Date: 11/1/06 12:50 PM

**Location** Address: **2801 GARRISON AVE**

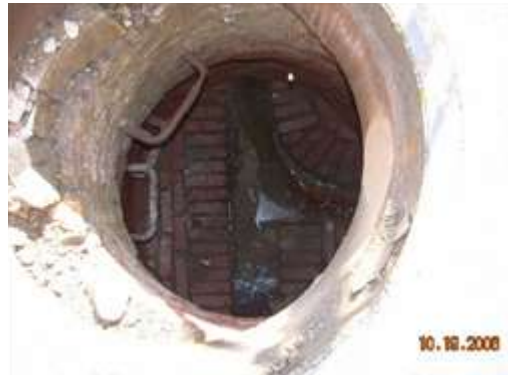
Top View

Condition: ☐ Sound ☒ **Cracked** ☐ Root Intrusion ☒ **Deteriorated** ☐ Leaks ☒ **Debris**

**Steps** Count: **3** Missing: **0** ☒ **Corroded**

Channel debris. Corroded steps.

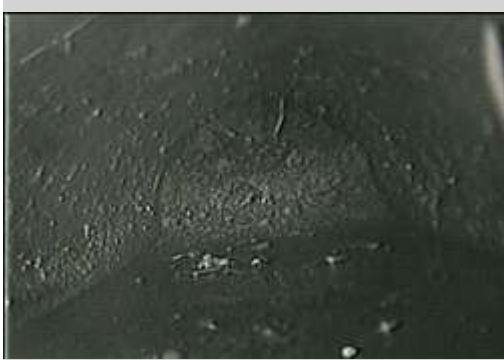
Inside of the I6

Inside of the I6.

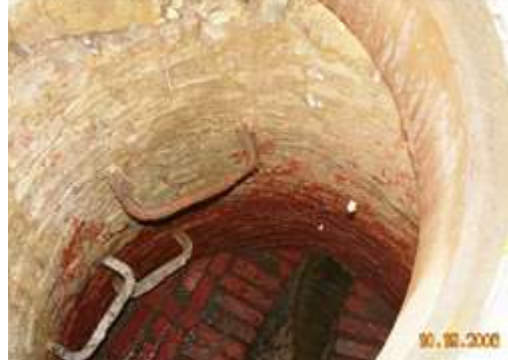
Defect

**Frame** Offset: **5** (in.) Condition: ☐ Sound ☐ Cracked ☒ **Leaks**

Condition: ☐ Sound ☐ Cracked ☐ Root Intrusion ☒ **Loose Brick** ☒ **Deteriorated**

Infiltration: ☐ None ☒ **Joint** ☐ Cracks ☒ **Mortar** ☐ Roots ☐ Wall

Frame leaks. Frame offset. Adjustment loose brick, deterioration, and infiltration - other side.

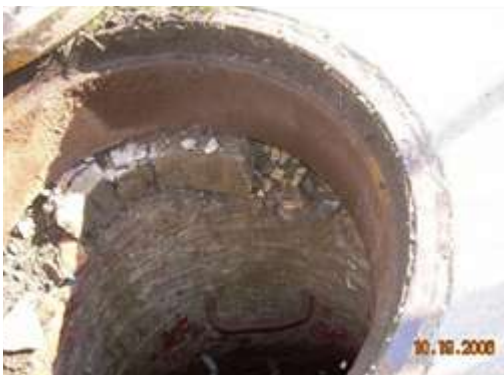
Defect

Frame leaks. Frame offset. Adjustment loose brick, deterioration, and infiltration.

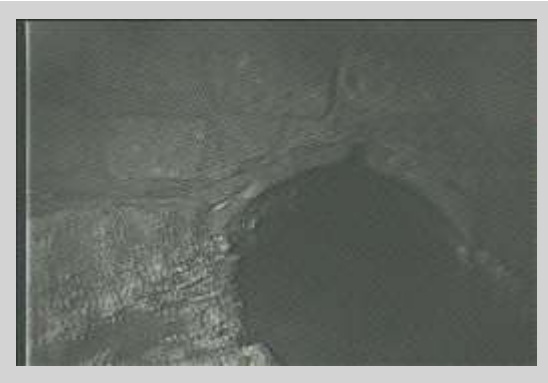
### 8 in. Circular Gravity Sewer Pipe Out @ 12 O'Clock

Deposits: ☐ None ☐ **Mud** ☐ Sludge ☐ **Debris** ☒ **Grease**

Infiltration: **None** Pipe Seal Cond: **Cracked**

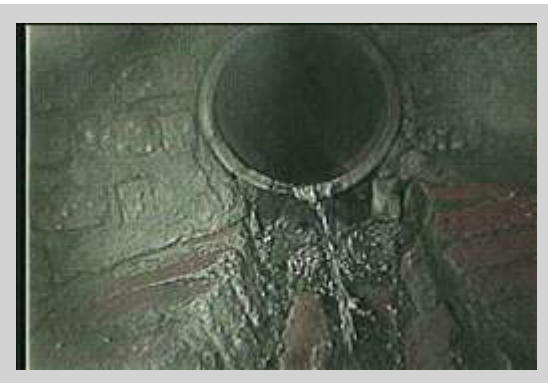
### 8 in. Circular Gravity Sewer Pipe In @ 3 O'Clock

Comments **The Channel has heavy debris. The I3 pipe picture shows Channel cracks and deterioration.**

Channel deterioration and cracks.

Infiltration: **Evidence** Pipe Seal Cond: **Cracked**

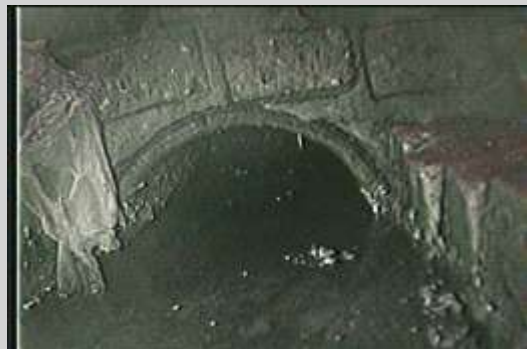
Pipe In @ 6 O'Clock

Deposits: ☐ None ☒ **Mud** ☐ Sludge ☒ **Debris** ☒ **Grease**

Infiltration: **Evidence**
